LEAD HAZARD EVALUATION NOTICE

**LEAD HAZARD RISK ASSESSMENT
LEAD-BASED PAINT TESTING REPORT**

New Jersey Landlord Rental Repair Program (LRRP)

**SRP0041091.01.01.D.0A6
1492 Ocean Ave, Unit A6
Sea Bright, New Jersey 07760
Property Owner: Chris Mosera**

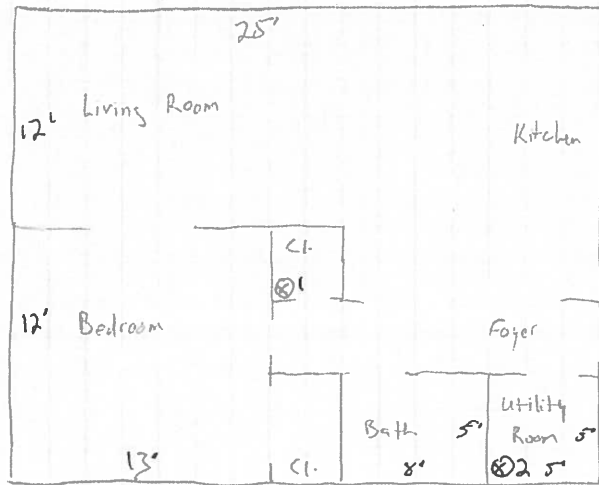
SITE PLAN

Suspect ACM
-Sheetrock

- Building Built in 1970's
- All Damaged materials have been removed + replaced upto 4"
- Lead RA complete/No Lead found
 - Testing limited to the interior of unit A6 Only
 - 9 wipes
- No crawlspace, No Attic
- No Roof
 - Unit A6 is on lower level of 3 Story Building
